EVALUATION OF CALCIUM-CHLORIDE
MAINTAINED, TRAFFIC-BOUND ROADS

George R. Laughlin
Research Engineer Associate

Highway Materials Research Laboratory
Lexington, Kentucky
February, 1962

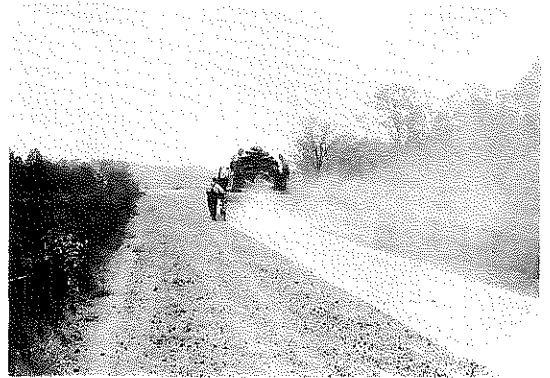
In applying the calcium chloride, six types of mechanical spreaders were employed. They were: 1) the lime drill, 2) Champion spreader, 3) Highway spreader, 4) Shunk spreader, 5) Gibbs spreader and 6) the Swenson spreader. The lime drill did not give an even application, the operation of this equipment was slow due to the frequent stops required to refill the hopper. The Champion spreader was unsatisfactory because of the slowness of operation and an excessive rate application (which could not be reduced). The Highway spreader applied the material evenly and operated satisfactorily. The Shunk spreader was more efficient in operation than the other types used. With this equipment, the application rate was consistent, the width of application was effectively controlled, and the entire operation was performed by the truck driver. Although the Gibbs spreader was efficient in applying the material, the application was uneven and frequently labor was required to unclog the equipment. The Swenson spreader was convenient to use in applying the material, but the application was uneven. The six types of spreaders used are depicted in Figs. 12 thru 17.

Fig. 13. Champion Spreader in Operation, Excessive Application.

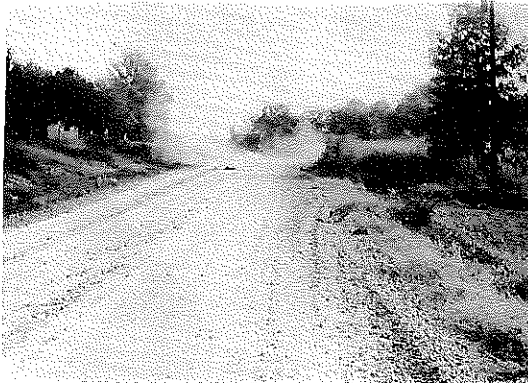
Fig. 14. Highway Spreader in Operation, Even Application.

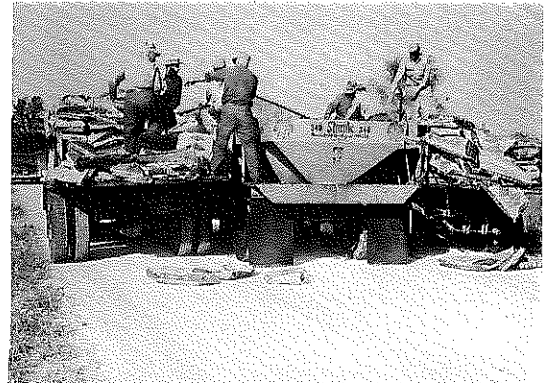
Fig. 15. Shunk Spreader in Operation, Even Application.

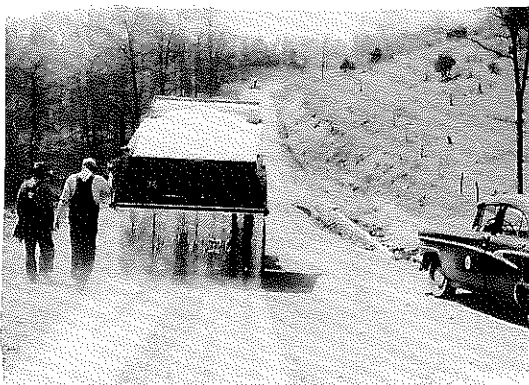
Fig. 16. Gibbs Spreader in Operation, Uneven Application.

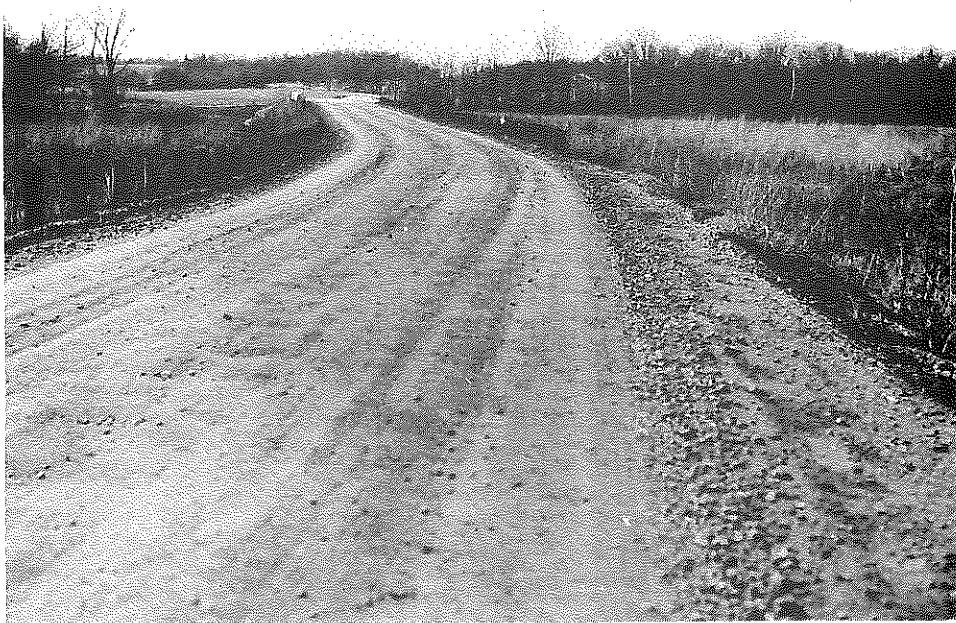
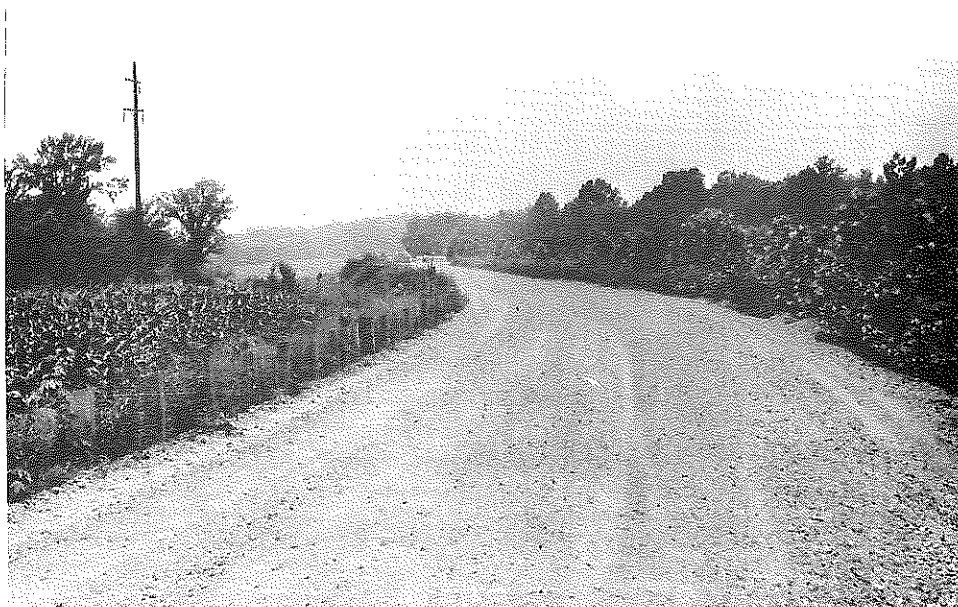
The bank gravel base of this road remained stable throughout the evaluation program. There was always an abundance of coarse floater on the surface. During wet seasons, water was impounded on the surface and shoulders where the crown was insufficient or lacking - giving rise to instability and bad appearance along the edges. The base thickness was sounded during periodic inspections and these thicknesses are given in Table 2. Figures 18 and 19 depict a section of this test road at the start of the evaluation program and near the end of the program.

Fig. 18. Calloway County, MP 018-203-D,
Spring, 1959.

Fig. 19. Calloway County, MP 018-203-D,
Summer, 1960.

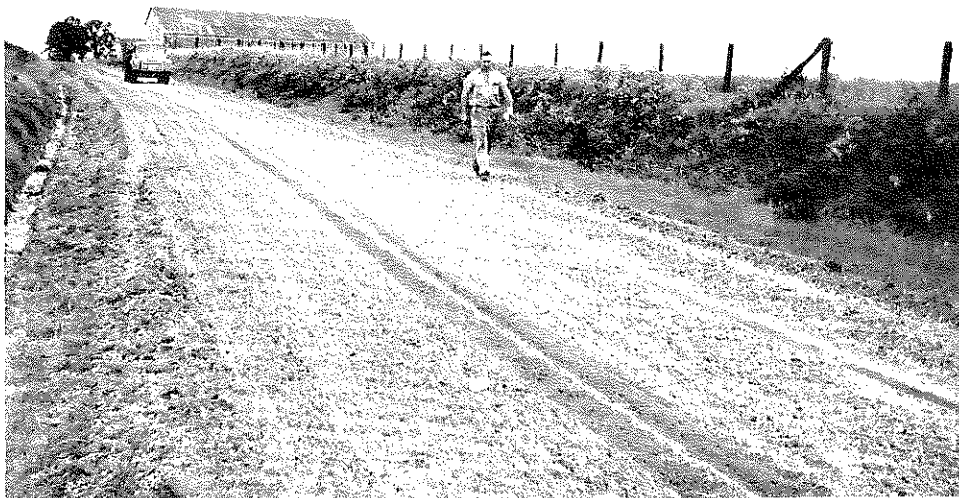
From the beginning of the evaluation period to the end, this road was observed to be unstable during the wet seasons. Since the base thickness was insufficient to withstand traffic, the surface rutted and gave rise to inadequate drainage; hence, the stability and appearance were not improved. Figures 20 and 21 depict a section of this road during the initial application of calcium chloride and in the summer of 1961. The base thickness measured during inspections of this road are given in Table 3.

Fig. 20. Breckinridge County, MP 014-733-B,
Fall, 1958.

Fig. 21. Breckinridge County, MP 014-733-B,
Summer, 1961.

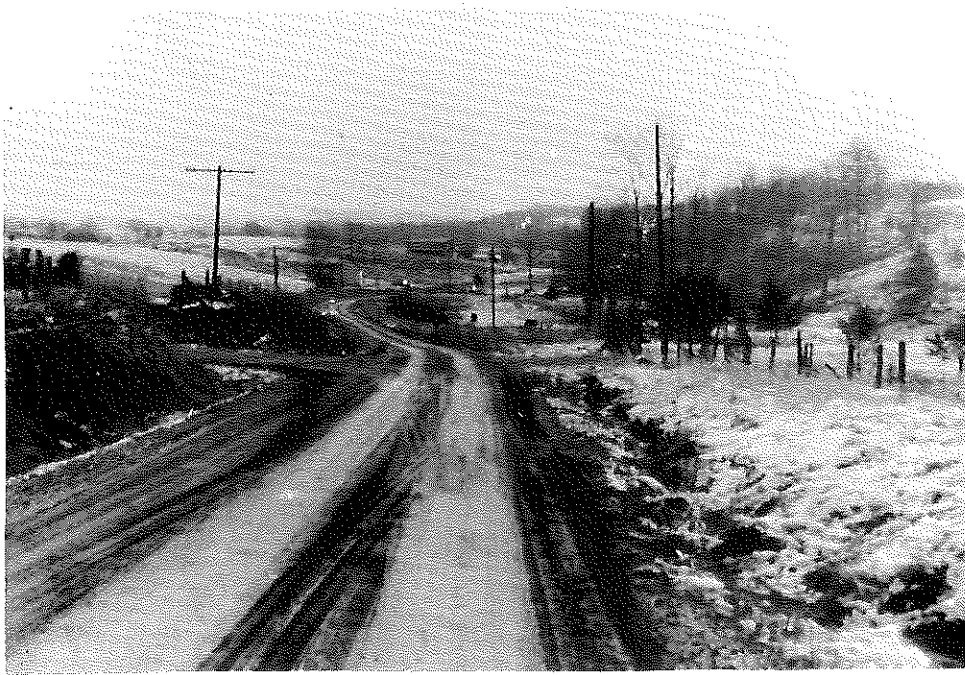
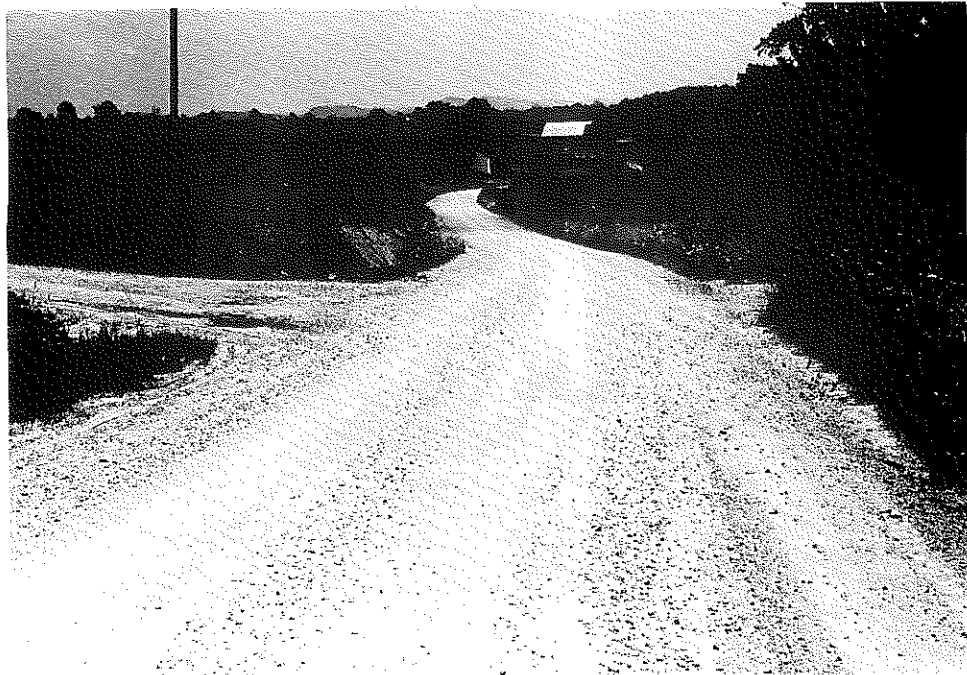
During wet seasons, the surface of this road rutted under traffic, giving a rough appearance. Table 4 lists the thickness of the base measuring during periodic inspections. Figures 22 and 23 illustrate the condition and appearance of a section of this test road.

Fig. 22. Pulaski County, MP 100-25-C, Fall, 1959.

Fig. 23. Pulaski County, MP 100-25-C, Summer, 1961.

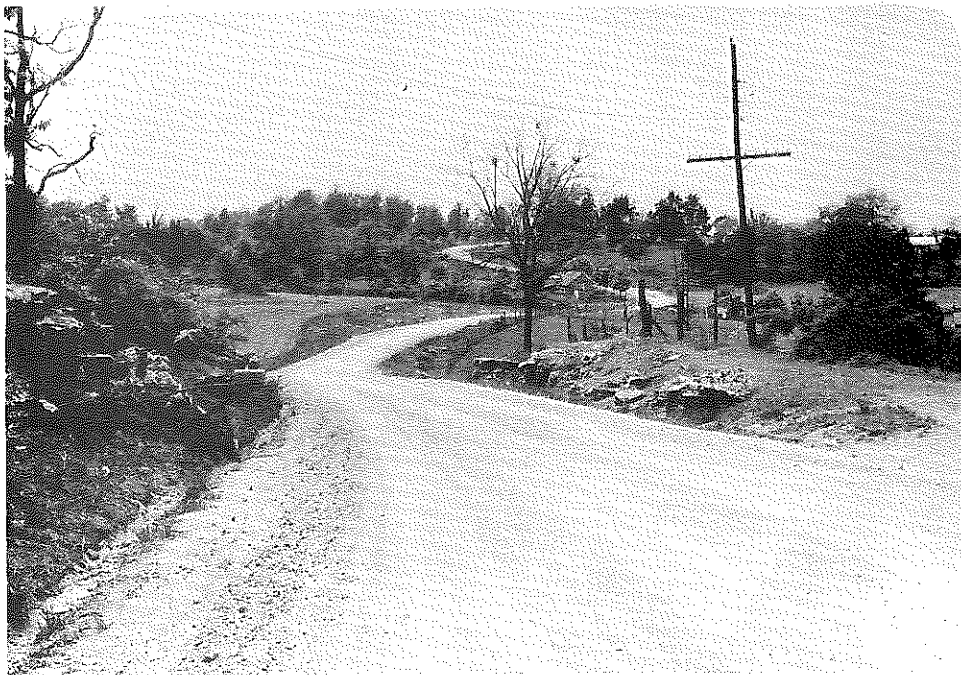
Although the base of this road was thin, the surface remained stable. The surface was kept highly crowned; blading was kept to a minimum and was performed when the surface was damp to ensure re-compaction of the loose material. The base thicknesses were measured during inspections and these data are given in Table 5. Figures 24 and 25 depict a typical section of this test road.

Fig. 24. Pulaski County, MP 100-855-E, Fall, 1958.

Fig. 25. Pulaski County, MP 100-855-E, Spring, 1960.

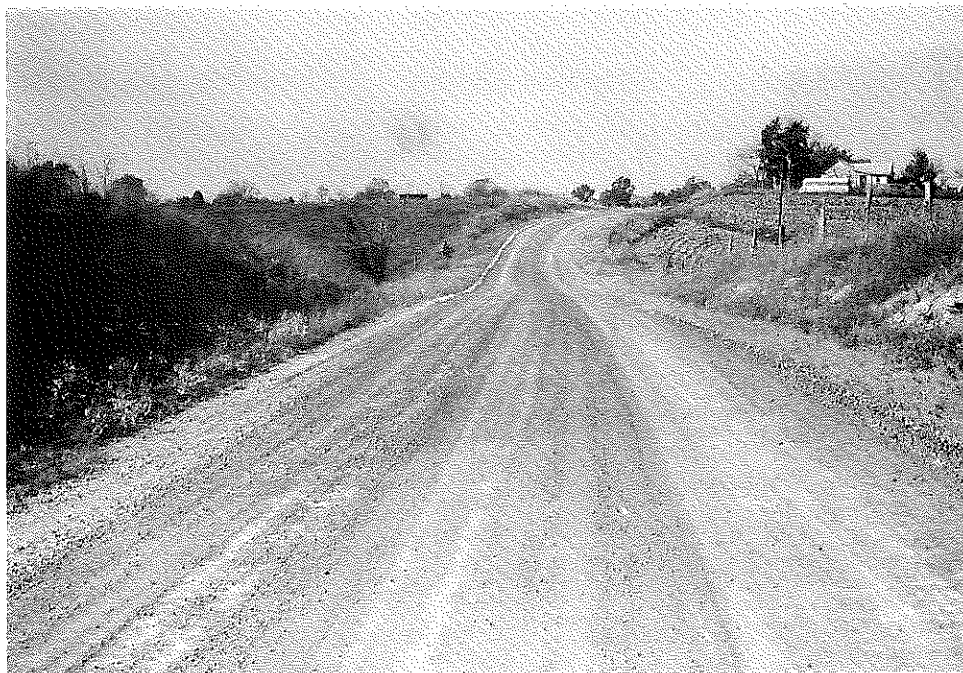
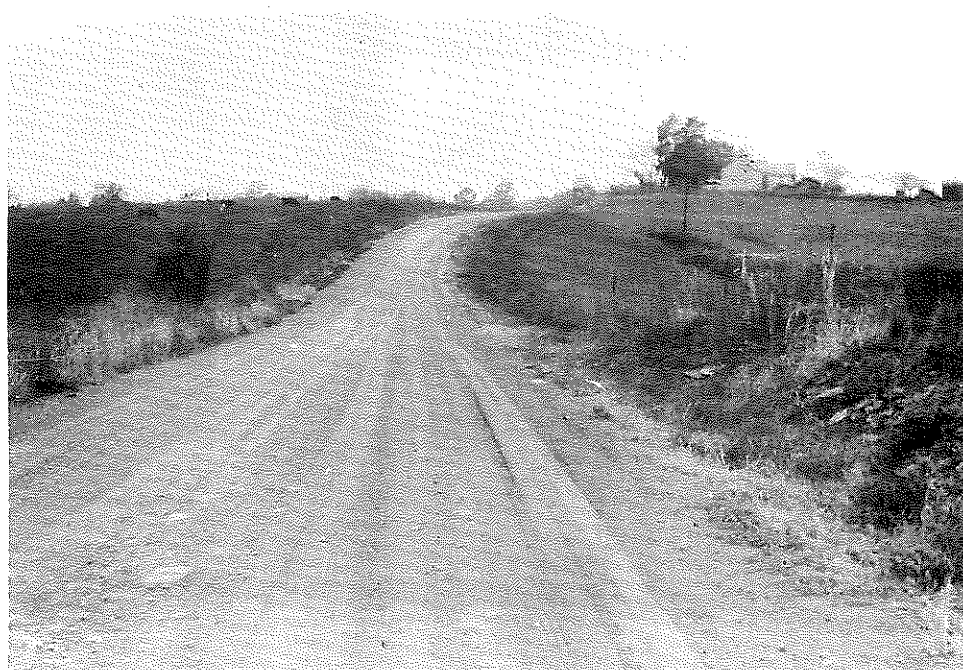
Large portions of the road were unstable in wet seasons. Table 6 shows the base thickness measured during inspections. Figure 26 depicts a section of this road after the initial application of calcium chloride. Figure 2.7 depicts the ~~same~~ section one year later, and shows an absence of base, with large limestone remnants protruding through the surface.

Fig. 26. Robertson County, MP 101-161-B,
Fall, 1958.

Fig. 27. Robertson County, MP 101-161-B,
Fall, 1959.

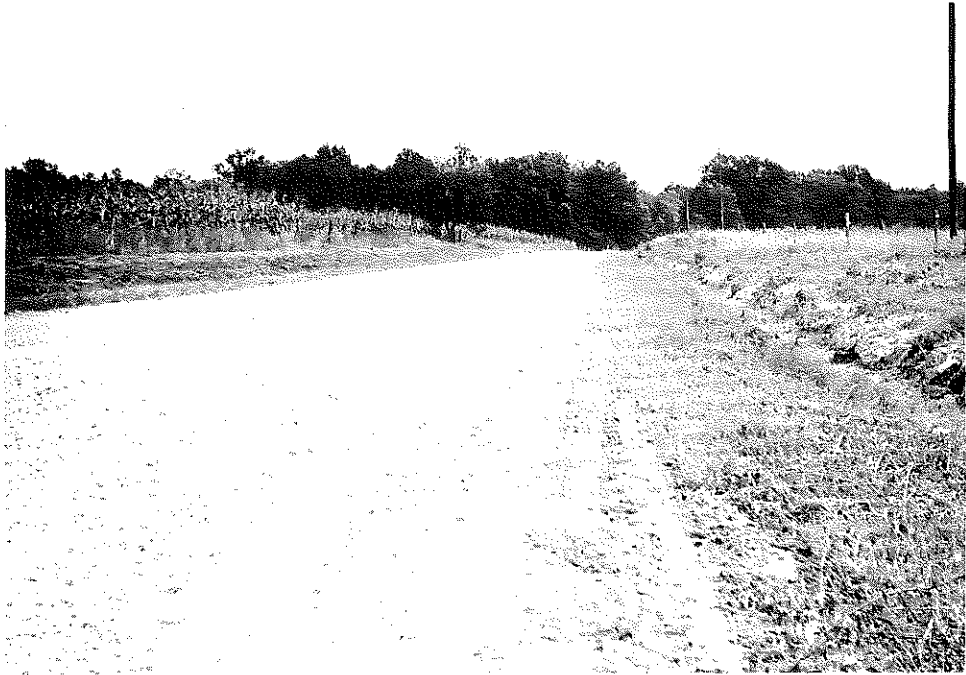
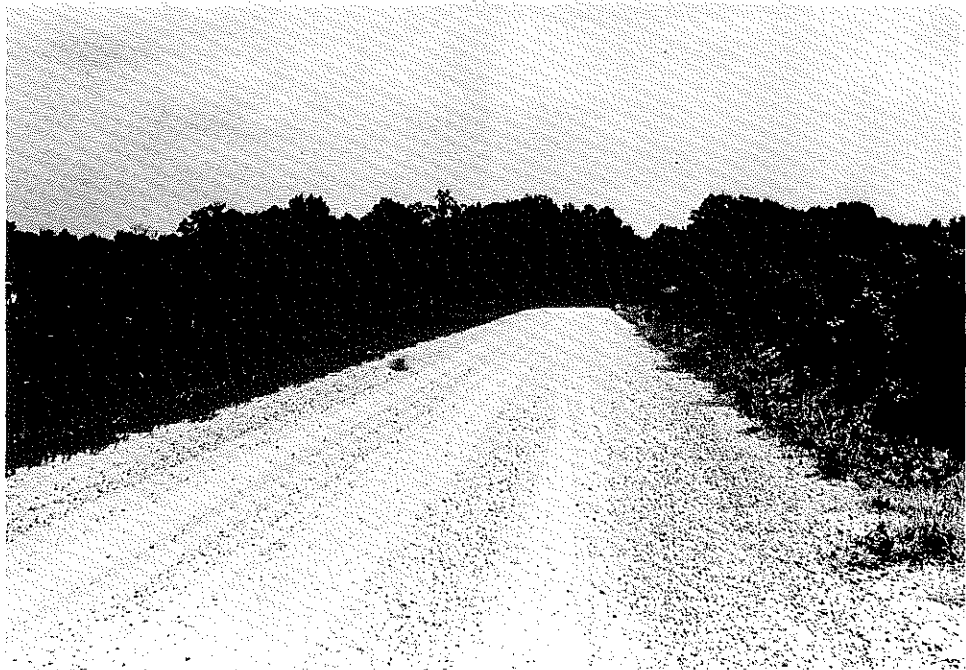
The surface remained stable during wet seasons, but the appearance of the road was not improved. There persisted on the surface an abundance of loose aggregate. Table 7 shows the base thickness measured during the evaluation program. Figures 28 and 2'9 depict the appearance of a section of this test road.

Fig. 28. Lincoln County, MP 069-450-B,
Fall, 1958.

Fig. 29. Lincoln County, MP 069-450-B,
Summer, 1961.

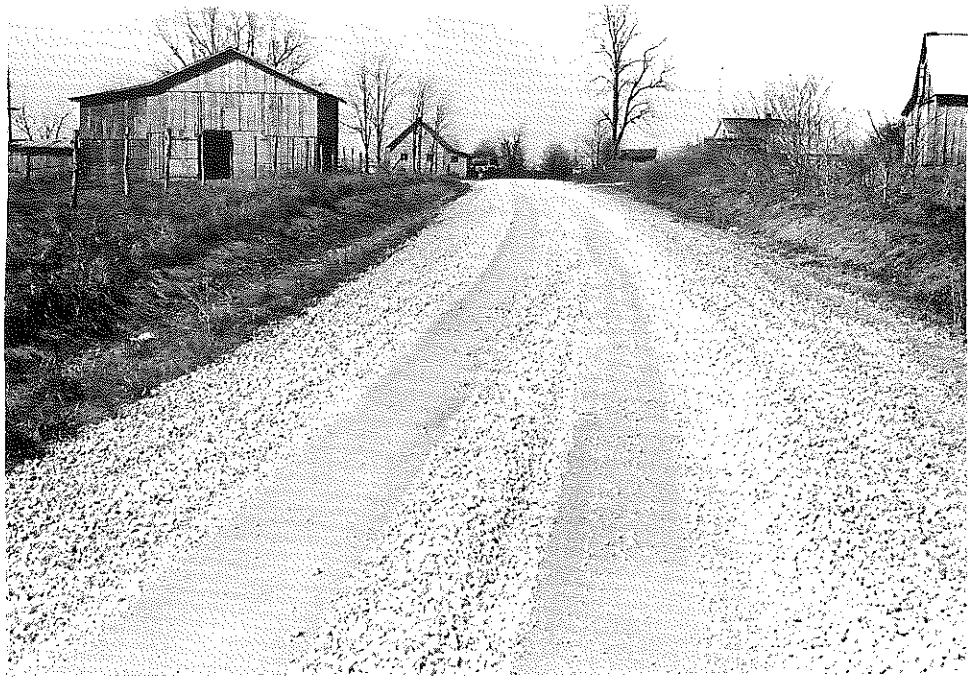
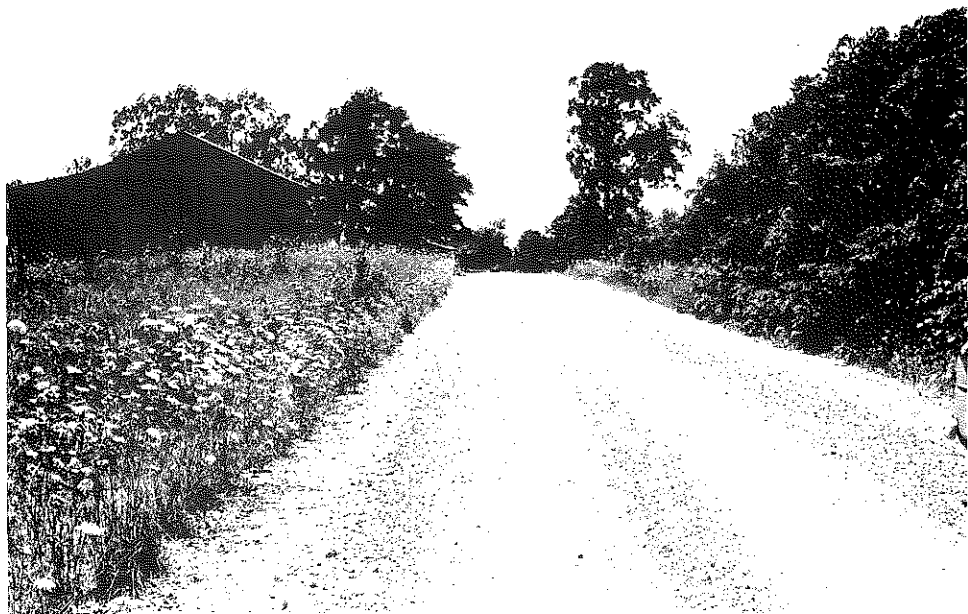
The base on this road remained stable throughout the evaluation period, but an excess of coarse, loose aggregate remained on the surface. Table 8 shows the base thickness measured during inspections. Figures 30 and 31 illustrate a section of this road, showing an excess of coarse, loose aggregate.

Fig. 30. Lincoln County, MP 069-510-B,
Fall, 1959.

Fig. 31. Lincoln County, MP 069-510-B,
Summer, 1961.
